## **Introduction**

The Watkins Creek Water Quality Monitoring Plan was designed by the Missouri Stream Team program to better understand the sources of the excessive levels of *E. coli* and chloride, which have been measured in the past few years near the mouth of the creek. Excessive levels of chloride are toxic to some of the macroinvertebrates, which would otherwise live in the stream, limiting its ability to support fish that feed on the macroinvertebrates. Excessive levels of *E. coli*, while not necessarily dangerous in themselves, are an indicator that levels of illness-causing bacteria might be high enough to cause illness to humans using the stream for recreational purposes.

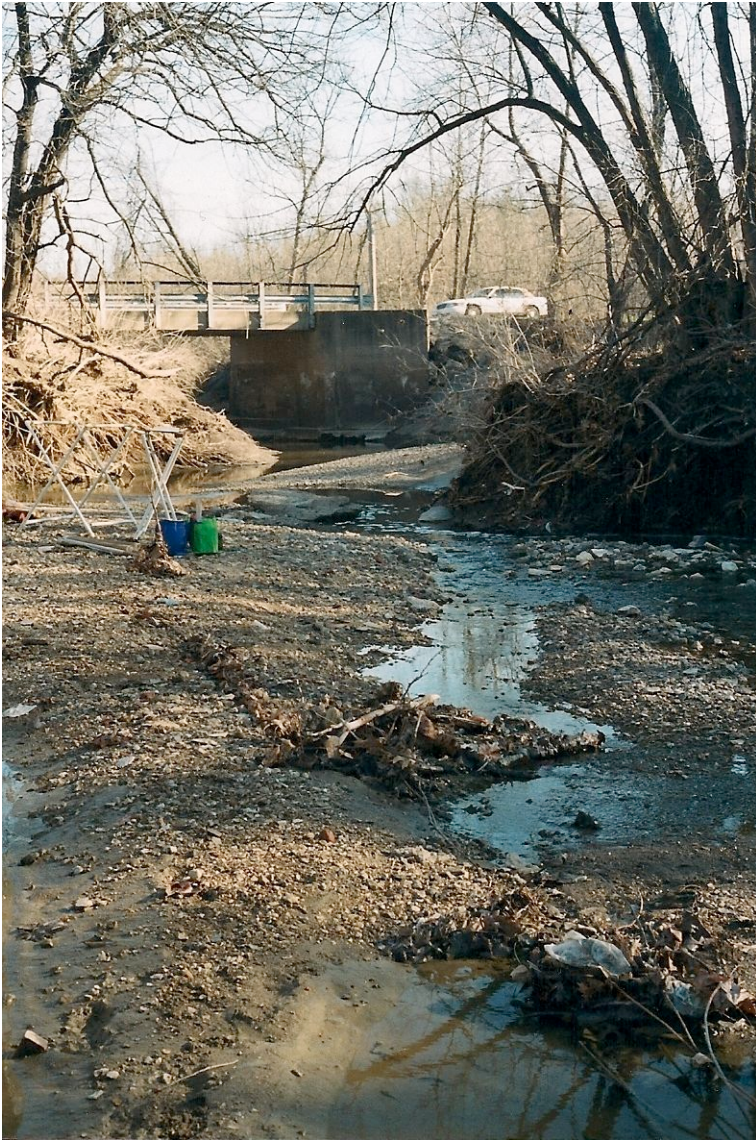
**Figure 4. Site 8, looking downstream from the sampling location. The Coal Bank Road overpass can be seen. Photo taken March 20, 2009.**

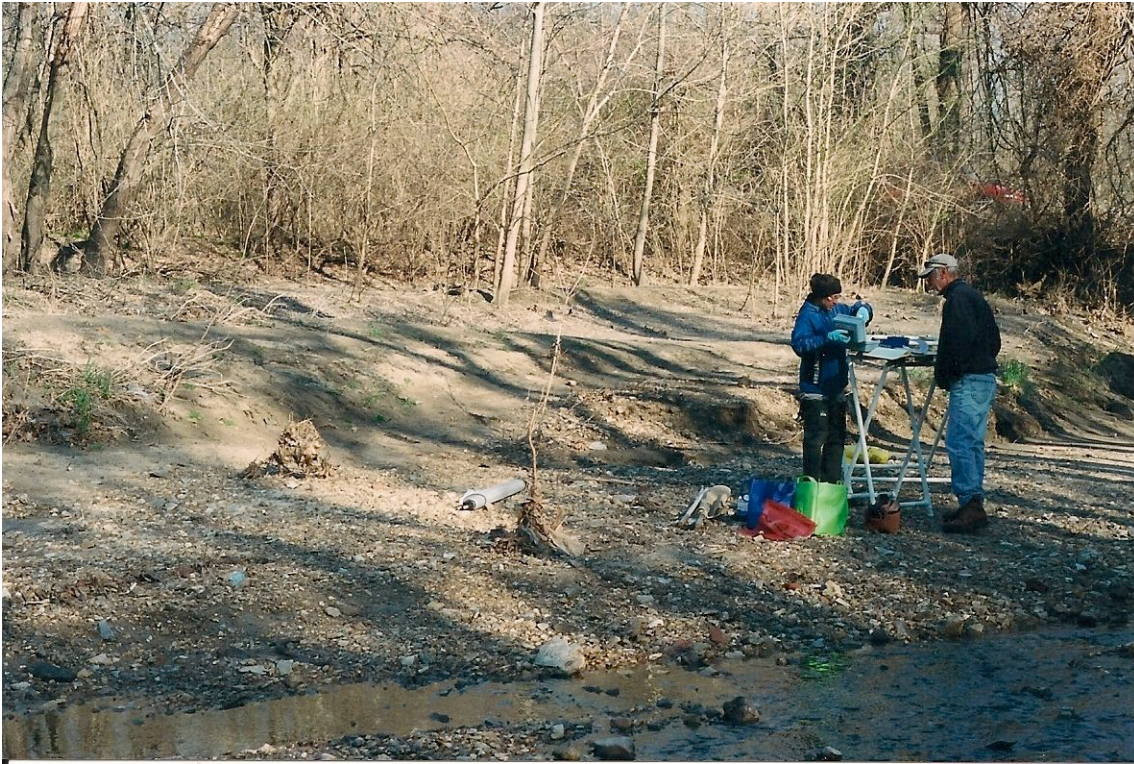
**Figure 5. Site 8, looking at the west bank of the stream at the sampling location. Photo taken March 20, 2009.**

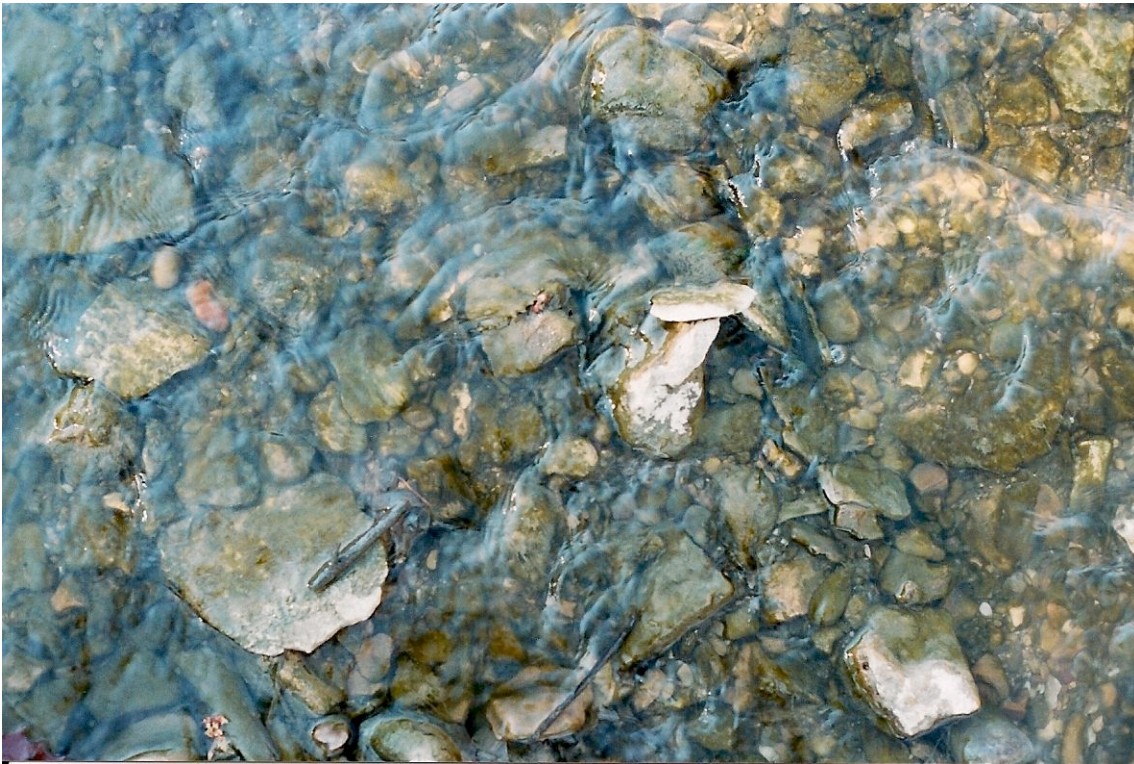
**Figure 6. Site 8, stream bed in a riffle that was sampled for macroinvertebrates. Photo taken March 20, 2009.**

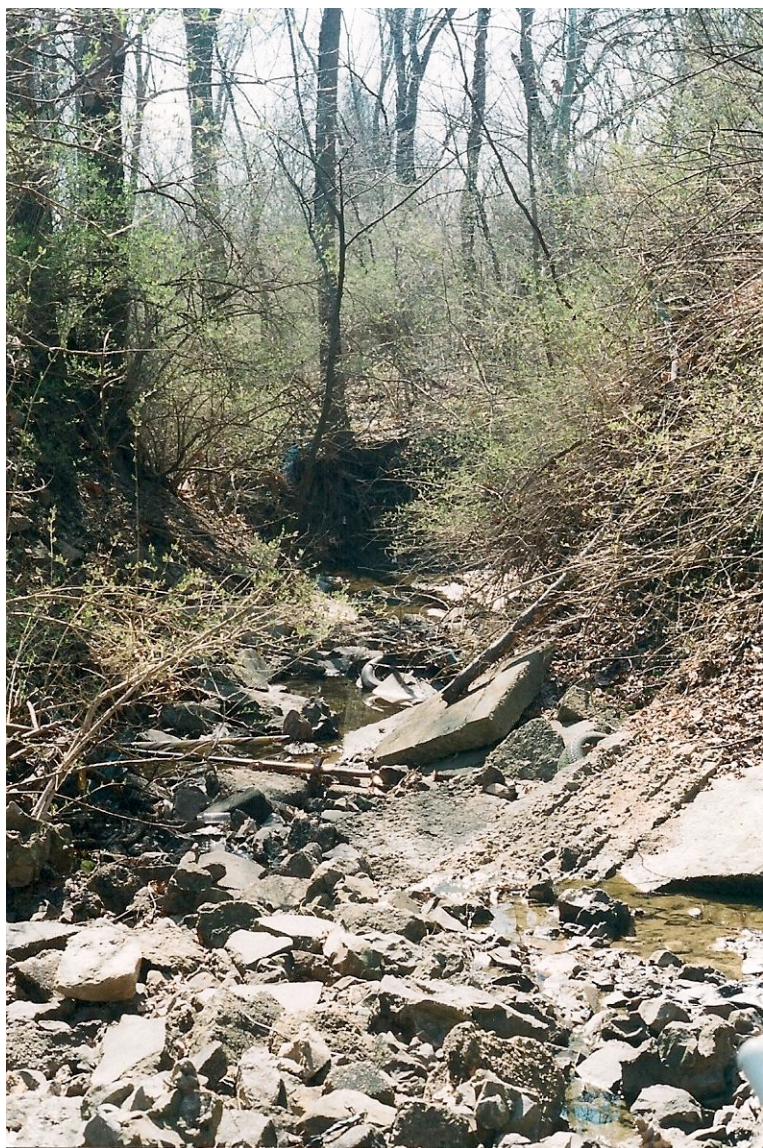
Site 14 also exhibits a V-shaped floodplain profile, the result of damming of Watkins Creek in Pennyrich Farms subdivision just above the sampling location which leads to very low flows most of the time and very high flows during periods of excessive rainfalls. The photos, shown below, and site survey indicate the poor physical condition of the stream at this site.

**Figure 8. Site 14, looking downstream from the sampling location, March 20, 2009.**

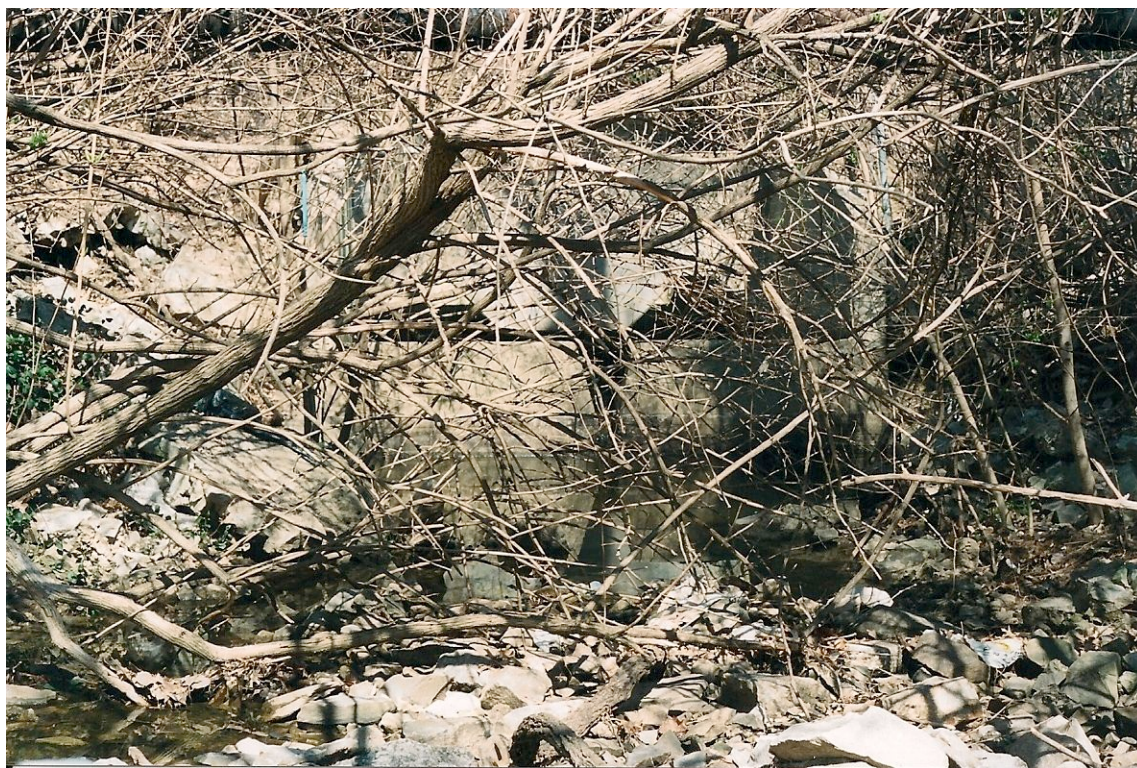
**Figure 9. Site 14, looking upstream from the sampling location. The dam can be seen. Photo taken March 20, 2009.**

The dam causes a no-flow condition during drought periods. Chloride levels at this site are the lowest at any site and always below chronic toxicity criteria, consistent with the lower proportion of salted surface at this site high in the watershed. *E. coli* levels were also lower at this site than any other on all but two occasions (7/1/09 and 9/28/09), and below MPN=126 on three occasions, suggesting that the major sources of *E. coli* in Watkins Creek are downstream of this location most of the time. This may be because there is very little watershed above the site to contribute to *E. coli* levels: few domestic animals or leaky sewers, for instance. The pond is known to attract ducks and geese - our team observed them on some of our sampling dates - but at least at certain times, wild birds do not seem to contribute much to *E. coli* levels at this site. This may be a result of fluctuating populations of birds on the pond. If sampling for *E. coli* could be conducted at times of high and low bird pressure, it might help to tease out any relationship or lack of it.

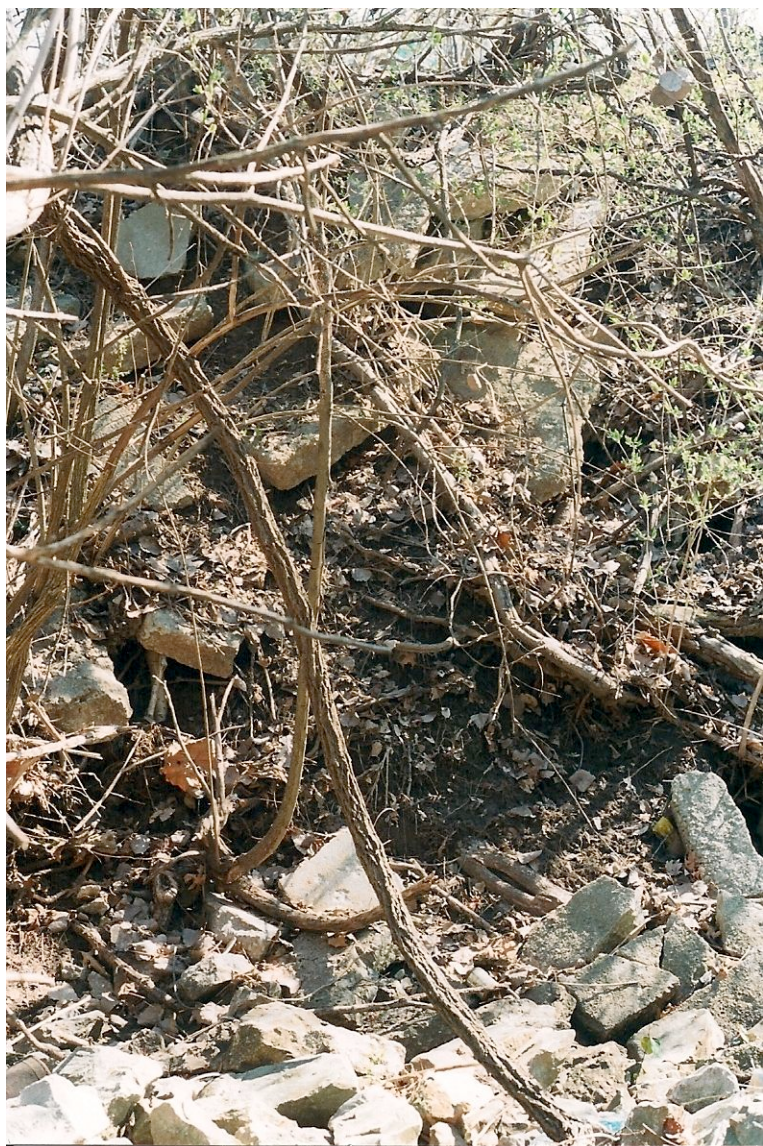
**Figure 10. Site 14, east bank at sampling location. Photo taken March 20, 2009.**

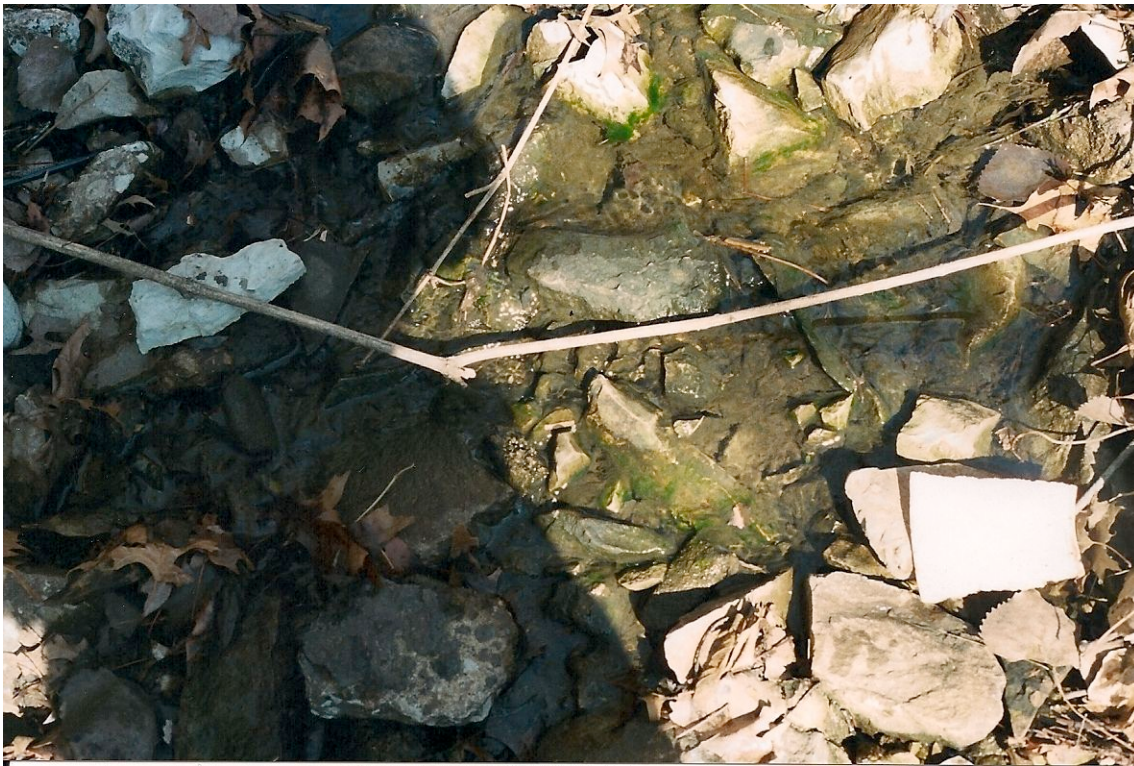
**Figure 11. Site 14, creek bottom at sampling location. Photo taken March 20, 2009.**
